Hygiene and Biofilm – a problem in the food industry

Per Væggemose Nielsen
IPU
Søtofts Plads, Building 221
pvn@ipu.dk
452 52631 / 2962 0843

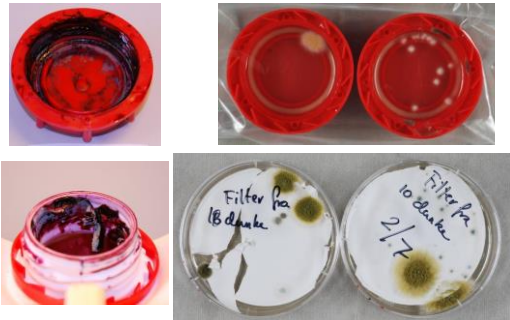
Case – Skimmelsvampe vækst i dunke med ingredienser

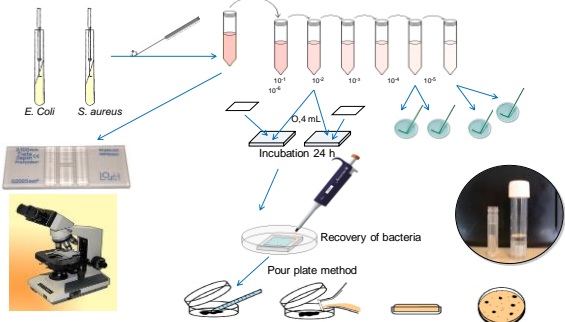
Measurement of antibacterial activity on plastics surfaces ISO 22196

JIS Z 2801 and ISO 22196

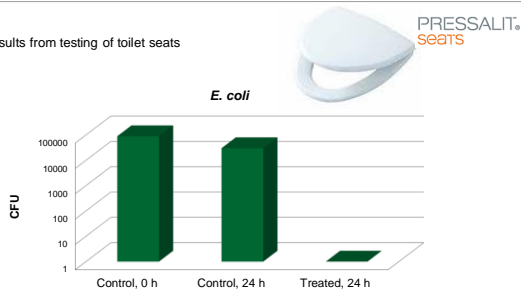
Measurement of antibacterial activity on plastics surfaces

- Results from testing of toilet seats

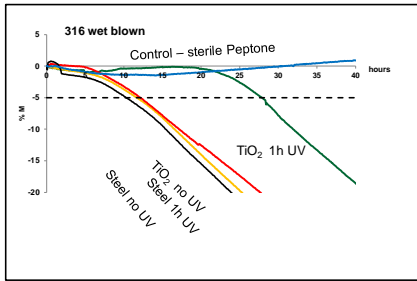
Inhibition of bacteria on TiO_2 covered steal surfaces

- 20 μl containing Ca. 5000 CFU *E. coli* bacteria added on each unit
- Incubate for 3 hours for adherence
- Irradiate UV 366 nm 1 hour
- No irradiation

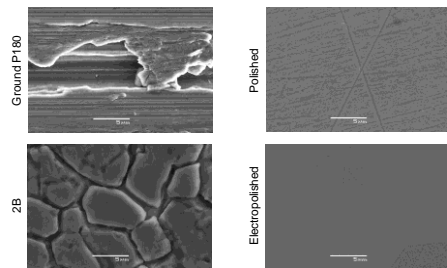
Topography of different surfaces

Examples of topography in x5000 times magnification

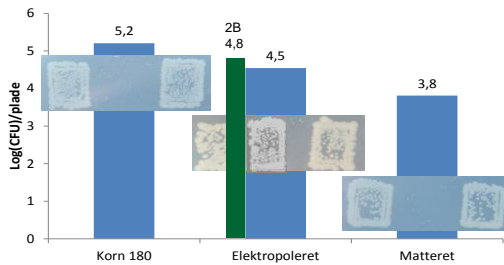
Clean ability

Agar-aftryk af 1x2 cm stålplader
CFU per plade er bestemt ved impedansmikrobiologi

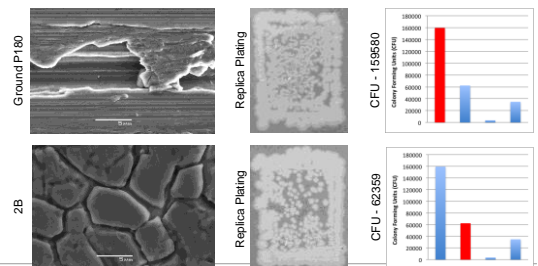
Obtained results by Impedance and Replica Plating

Examples of selected surfaces

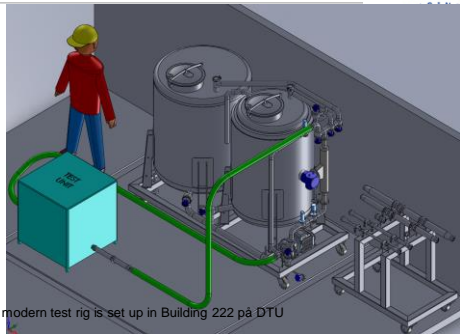
Test rig

A top modern test rig is set up in Building 222 på DTU

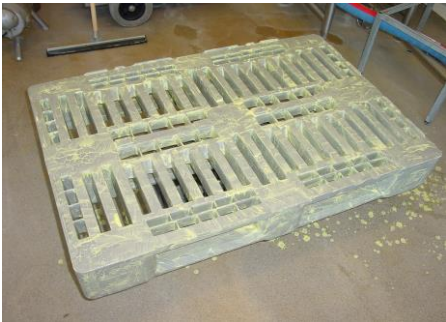
Plastic pallet soiled

Soured milk with 0.012 % (w/v) Uranine AP

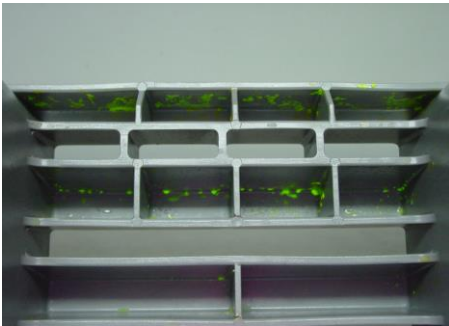
After cleaning

Standard cleaning 6 passages with a high pressure cleaner

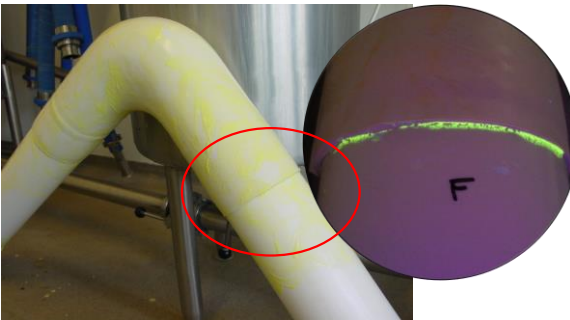
Insulated tube
